Bio Clean Provides Emergency Service Alleviates Flooding

Bio Clean Service Crew Instrumental in Customer Satisfaction

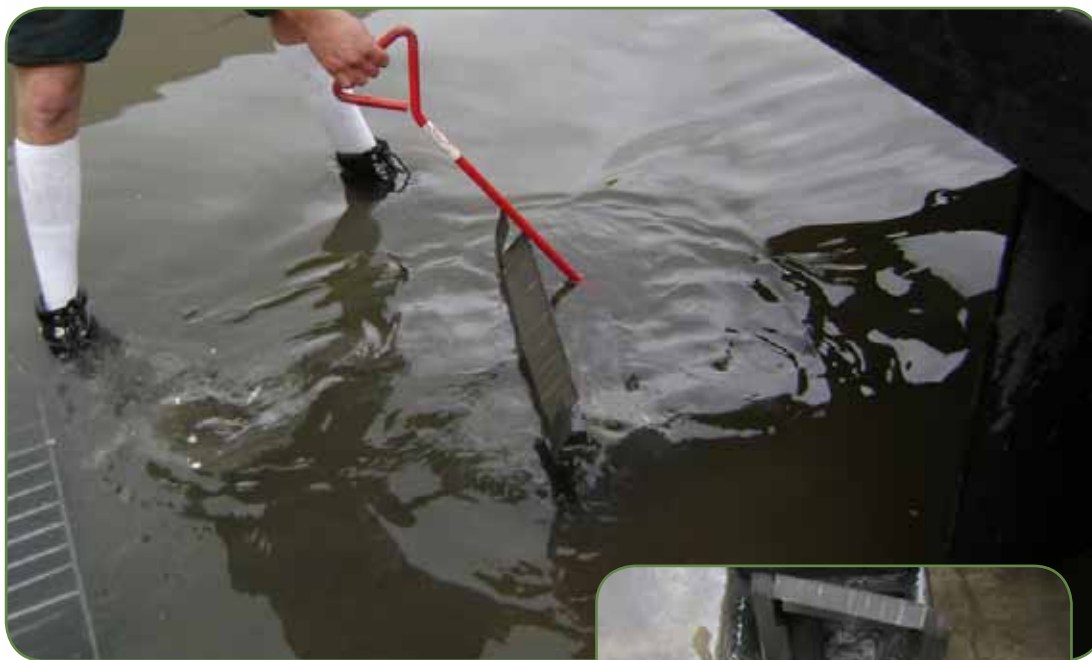
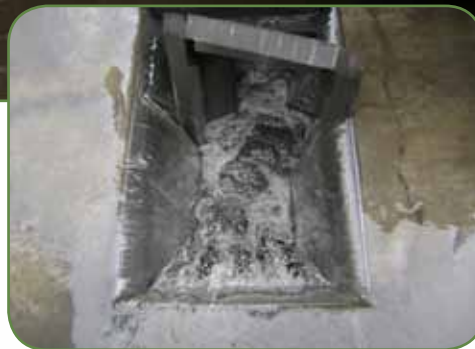
A call was placed to Bio Clean from a customer in need of emergency services. They reported a flooded parking lot as the result of a potentially clogged catch basin. A new stormwater filter had recently been installed and the client believed it to be the source of the problem. They first called the filter manufacturer for assistance. Unfortunately, they were met with little support for their issue and were dismayed with the overall care from the manufacturer. The client then turned to Bio Clean Environmental Services, Inc., who immediately dispatched a maintenance team to visit the site.

Upon arrival, the team assessed the condition of the catch basins. The grates covering the catch basins were removed and the team began to probe the basin in order to uncover the cause of the clogging. "We initially believed the clogging was due to a lack of maintenance on the filter. Many of our competitors' filters do not have appropriate bypass systems which cause clogging once the filters become full. When we began investigating the basin, we were unable to locate the filter. As we reached deeper, we found a fabric bag that had been caught in the bottom of the basin. The bag had been clogging the outflow pipe and as soon as it was removed, the water instantly began draining properly. After fully draining, we discovered that the cause of the clogging was actually the filter itself" (Aaron Kent—Bio Clean Maintenance Supervisor).

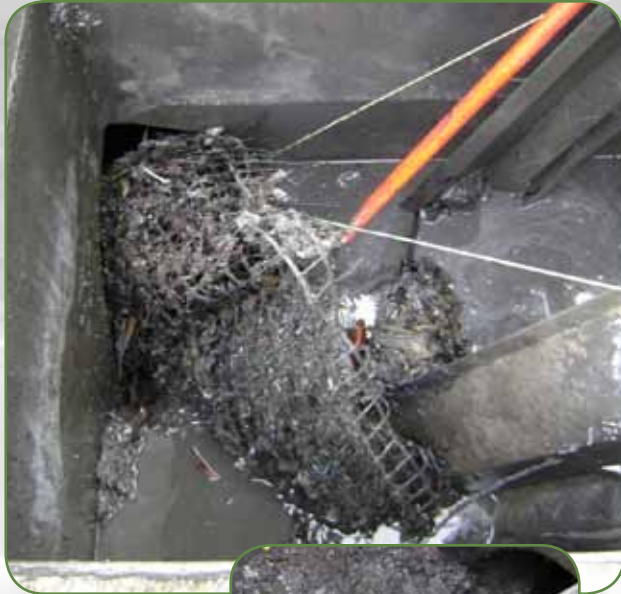
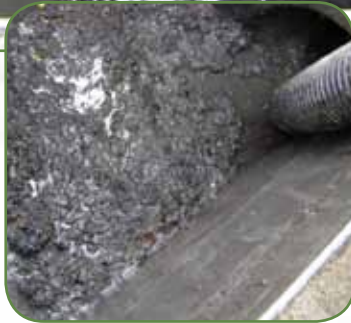
The stormwater filter bag had broken off of its upper metal framing. The lower filter bag was made of a geo textile fabric that could not hold the weight of the filter being full. "We see this time and time again. Many of the filters on the market are made of a geo fabric. This material is not suited for these types of loads. Additionally, they deteriorate over time and are easily burned by cigarettes and punctured by sharp objects" (Daniel Sroufe—Bio Clean Maintenance Supervisor). Not only did the filter bag break off, but the upper metal mount was also bent and caused the entire filter to fall into the catch basin. "We couldn't believe that after a rather serious failure in their equipment, the manufacturer refused to help the customer or replace their defaulted product" (Aaron Kent—Bio Clean Maintenance Supervisor).

The Bio Clean maintenance team removed the broken filter and vacuumed out the clogged catch basins. Several pounds of debris and pollutants were removed from the two catch basins in which the filter failures occurred. The team recommended to the client a more appropriate filter be installed in order to prevent the situation from occurring in the future. "We sell a great filter that is made of marine grade fiberglass and stainless steel. We use these materials because we want to provide our customers with a quality product with lasting effects. While our competitors only guarantee their products for up to one year, we stand behind ours with a 5 year unlimited warranty" (Daniel Sroufe—Bio Clean Maintenance Supervisor).
